Manhole Inspection Summary

Manhole # S27E__013MH

Insp Date: **8/21/07 11:13 AM**

Location Address: **931 LEXINGTON ST**

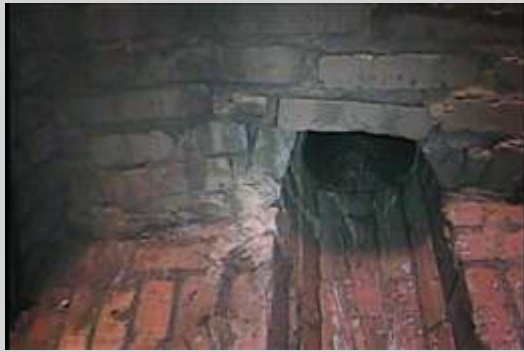
6 O'Clock Inflow

Pipe In @ 6 O'Clock

Pipe Height: **8.4** (in.) Rod and Bar (Angled)

Infiltration: **None** Pipe Seal Cond: **Sound**
